SERVICE INFORMATION

Service Information # 2940-198 pivot repair kit

Product: 2940 Air Adjust parallel link row cleaners

Model #'s: 2940-001, 002, 003, 004, 005, 006

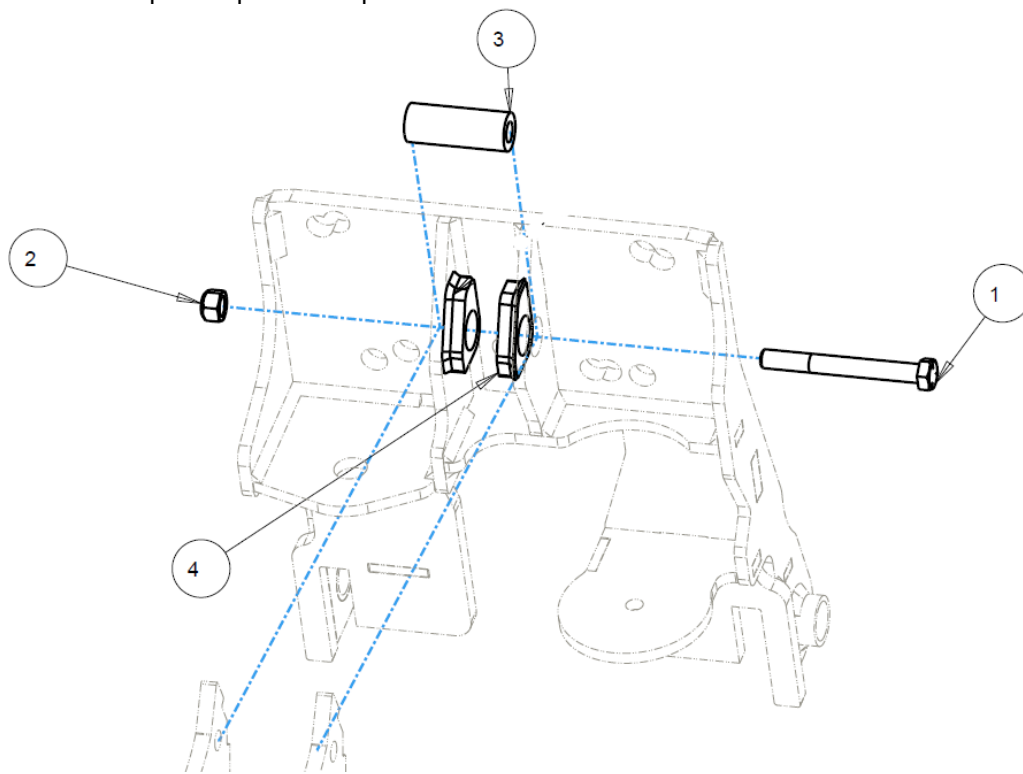
Step 1: Remove the upper parallel link bolt and bushing. Grind paint off surface to be welded. Use the bushing to locate the pivot repair tab in position

Step 2: Weld in pivot repair tabs. Paint after surface has cooled.

Step 3: Put in new pivot bushing and reassemble parallel arm.
